**MEANDER PLAN, SINUOSITY AND BANK EROSION ALONG RIVER SEMLIKI
IN NTOROKO DISTRICT, WESTERN UGANDA**

**A DISSERTATION SUBMITTED TO THE FACULTY OF NATURAL RESOURCES
AND ENVIRONMENTAL SCIENCES IN PARTIAL FULFILMENT OF THE
REQUIREMENTS FOR THE AWARD OF A MASTER OF SCIENCE DEGREE IN
CLIMATE CHANGE AND DISASTER MANAGEMENT OF BUSITEMA
UNIVERSITY**

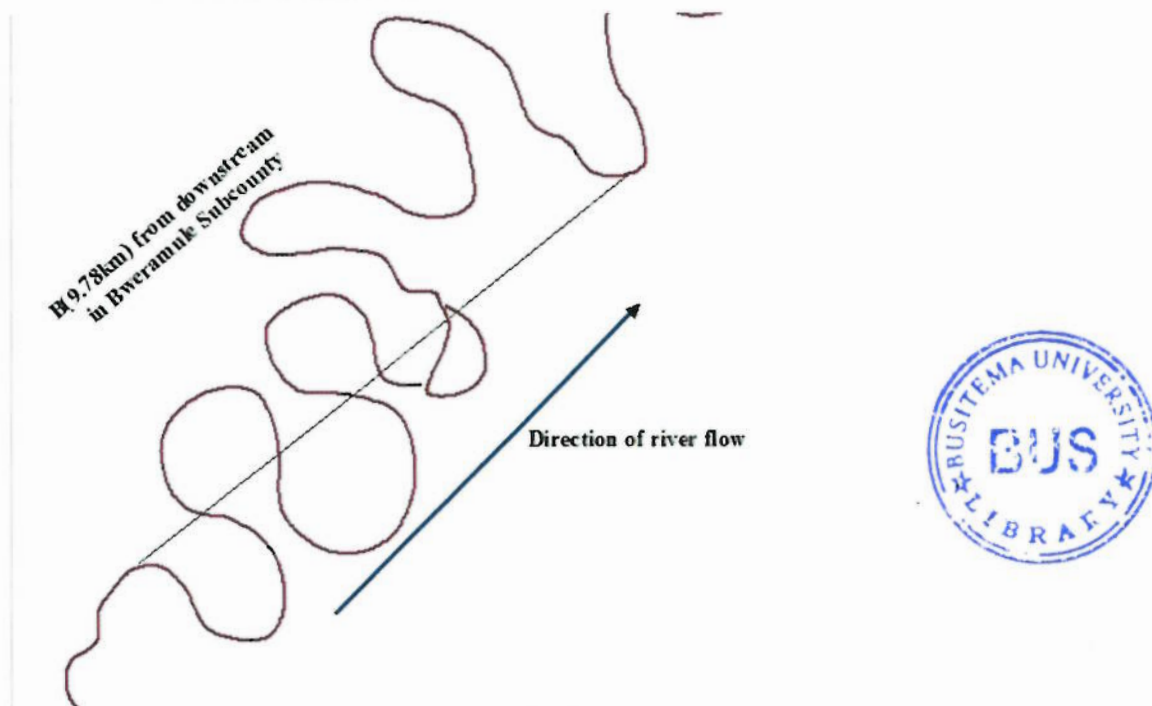
Figure 0-1: shows an illustrates the meandering pattern of River Semliki and formation of ox-bow Lake as a result of neck cut off.

The sinuosity index was calculated by taking continuous points along the entire length of the River channel using the formula RL/VL where RL is the River length between two points on a River, and valley length is the straight line distance between the same two points. The sinuosity of River Semliki was determined using ArcGIS 10.1 software whereby the images for the five time series were digitized and the datasets were used to identify the meander sections of the River. Four segments (A, B, C and D) were selected in areas where the meanders have been

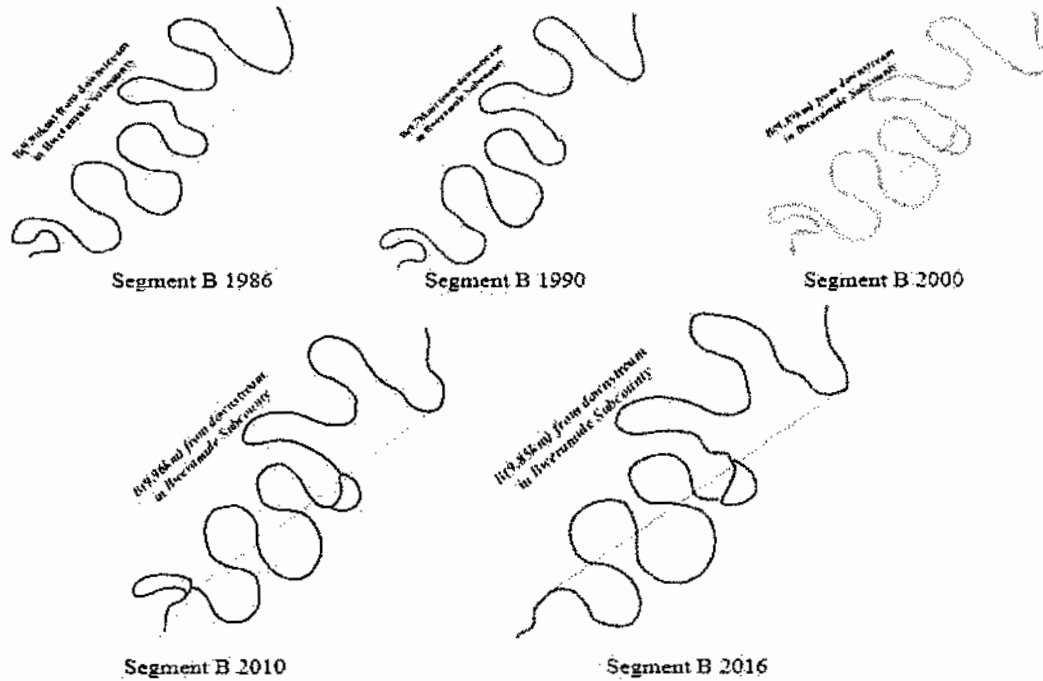
Figure 0-5: Changes in Sinuosity over the years along River Semliki

It was noted that most segments of the River Semliki are not straight with the majority exhibiting meanders as shown in Appendices 1, 2 and 3. The entire River and particular segments of the River (1986 to 2016) (Figure 4.5) were considered when calculating the sinuosity (Table 4.1). These individual segments are illustrated in Appendix 21.

The sinuosity indices obtained in this study increased towards downstream the River channel. The sinuosity index was highest as the River flows through the fluvial sediments region of the study area (Segment B). The sinuosity of the River varied from 1.18 to 4.09. Thus River Semliki may be termed as a highly meandering River based on the classification suggested by Leopold and Wolman (1957). The meandering nature of the River is responsible for frequent course change of the River as it flows through the plains of Ntoroko. Several types of meander bends along its bank line have been observed on overlaying the River layers of 1986, 1990, 2000, 2010 and 2016 thus leading to frequent shifting of the bank line of the River.

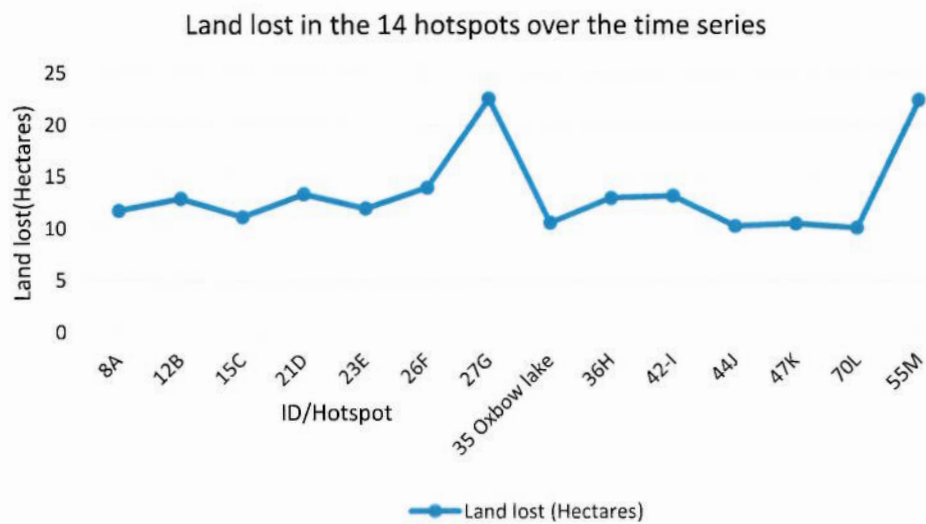
Figure 0-7: Land loss in Hectares at different segments over four time series in River Semliki

Potential hotspots	1986-1990 (Ha)	1990-2000 (Ha)	2000-2010 (Ha)	2010-2016 (Ha)
1	2.596	0.369	1.432	1.923
2	0.784	1.648	1.183	4.214
3	1.417	0.625	0.546	2.688
4	2.100	1.830	3.429	2.011
5	0.244	0.288	0.957	3.746
6	0.520	0.312	0.229	8.110
7	4.561	3.021	2.605	2.700
8	4.733	1.639	0.733	2.533
9	1.182	1.403	0.316	1.000
10	0.486	0.560	0.577	4.223
11	0.408	0.967	0.373	9.218
12	4.564	2.434	1.134	8.563
13	1.134	3.057	2.280	0.517
14	1.261	1.411	1.538	1.221
15	0.074	2.474	1.086	1.544
16	1.386	0.914	1.191	0.757
17	0.050	0.940	1.049	0.603
18	2.834	2.058	0.470	4.854
19	1.126	1.299	1.348	1.655
20	1.647	6.350	4.059	2.463
21	0.316	0.923	1.757	3.350
22	0.839	5.190	0.469	10.555
23	0.584	2.501	0.345	2.566
24	0.341	0.830	1.612	1.021
25	2.547	5.225	0.601	22.834
26	1.154	2.560	1.294	1.332
27	9.884	0.569	0.727	1.397
28	0.500	1.042	0.359	6.292
29	6.392	2.612	0.339	1.477
30	0.865	1.169	0.522	1.257
31	0.341	2.621	0.108	4.778
32	7.593	0.273	0.398	0.389

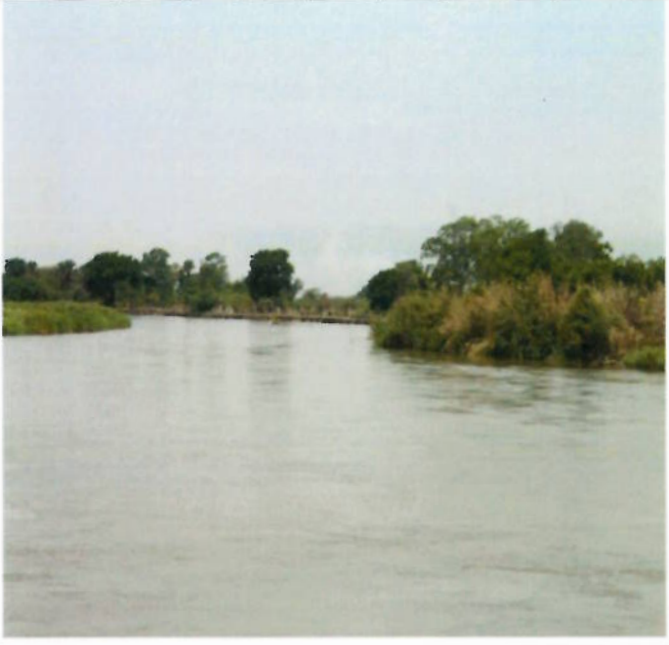
Figure 0-8: Vegetation and major plant species along River Semliki

These were mainly located on permanently water logged areas adjacent to the Riverine forests and along shores of Lake Albert. The areas were dominated by *Phoenix reclinata* swamp forest and *Cyperus papyrus* swamp.

<p>The common Riverine forest vegetation type included the <i>Celtis-Chrysophyllum</i> Riverine forest. The main canopy Riverine tree species is Ugandan ironwood (<i>Cynometra alexandri</i>), followed by <i>Millettia dura</i> and <i>Kigelia africana</i>. The understory was dominated by <i>Beilschmiedia ugandensis</i>, by far the most common tree in the Riverine forests. <i>Celtis africana</i>, <i>C. intergrifolia</i>, <i>C. mildbraedii</i>, <i>C. brownii</i>, <i>Albizia grandibracteata</i>, <i>A. coriaria</i>, <i>Chrysophyllum sp.</i>, <i>Phoenix reclinata</i>, <i>Polyscias fulva</i>, and <i>Cola gigantea</i></p>

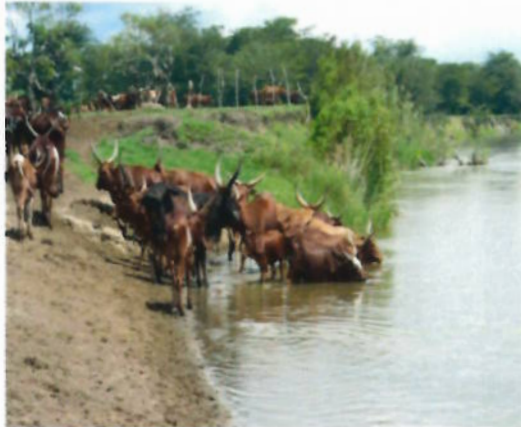
It was observed that most meanders astride devegetated land were rapidly migrating both on the Ugandan and Democratic Republic of Congo side. This implies that role of vegetation in holding together soil particles and the resultant reduction of River bank erosion is forfeited (Plate 4.1 and 4.2). It was also noted that all places along the River used as animal water points are degraded and weakened, setting up banks that are easily scoured by the River. (Plates 4.3 to 4.4).

Plate 4.1: Overgrazing along River Semliki

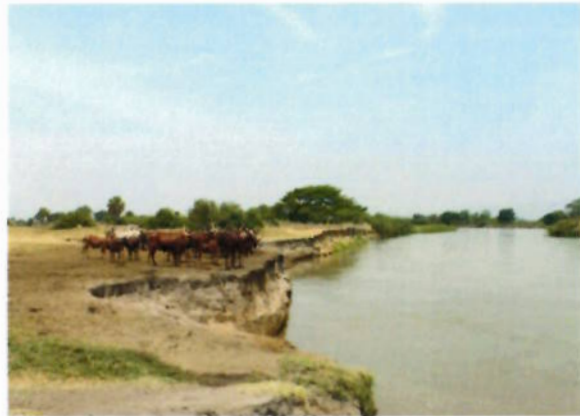
Plate 4.2: Bare land along River semliki

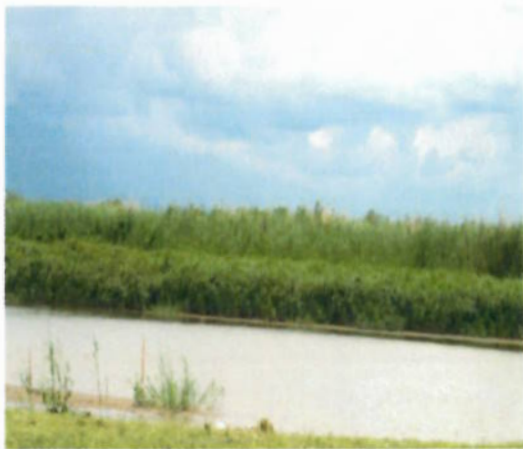
Plate 4.3: *Phragmites* along River Semliki

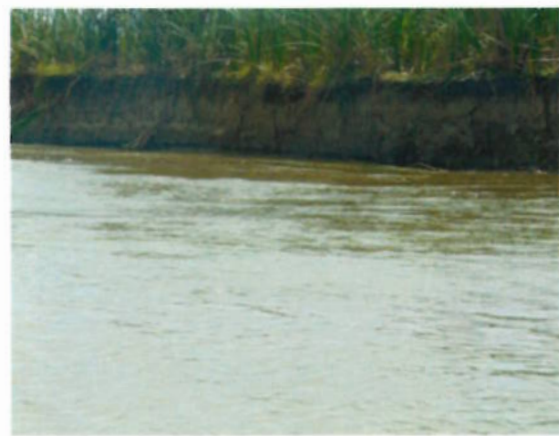
Plate 4.4: *Typha* on Semliki River bank

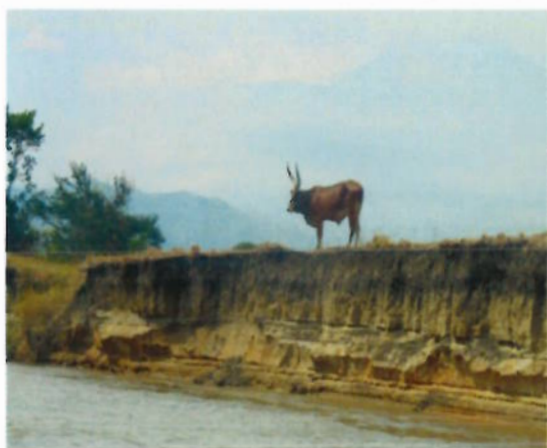
In the Semliki flats, there were sections where the landscape bears evidence of profiles with two parent materials hence successive depositional cycles in places. Where clay seems to dominate the surface and sub-surfaces horizons, the structure of the soils is columnar (Plate 4.7). Sand seems to dominate sub-horizons in places (Plate 4.8).

Plate 4.5: Soil profile along River Semliki banks

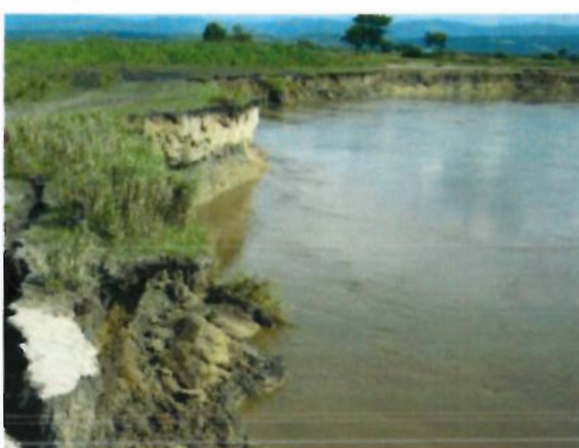
Plate 4.6: Loose soil at River Semliki banks

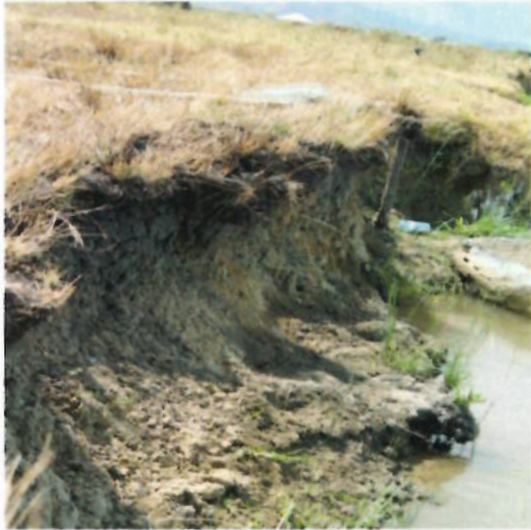
Plate 4.7: Soil profile at a meander

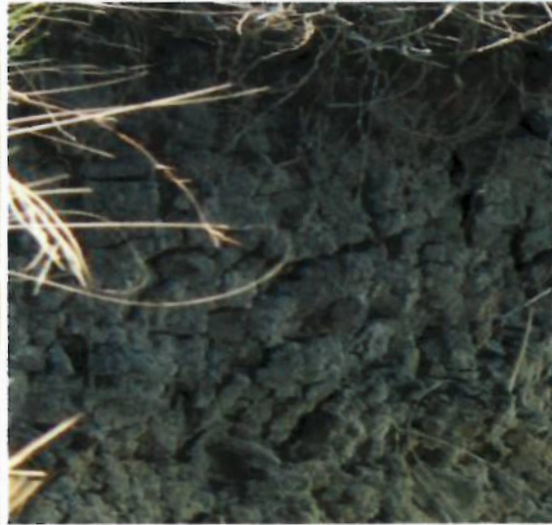
4.8: Blocky soil structure on River Semliki banks

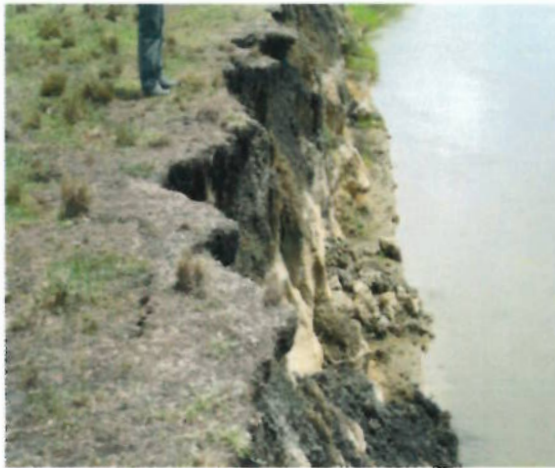
A quick test of rupture resistance revealed that the soils along the banks of River Semliki were firm but weakly cemented and hence prone to erosion. This is also the reason they easily curve-in under stress from animal trampling and is the cause of the bank slumps that accompany light rains and bank-full flows (Plate 4.9 and 4.10).

Plate 4.9: Fragility of soils along River Semliki

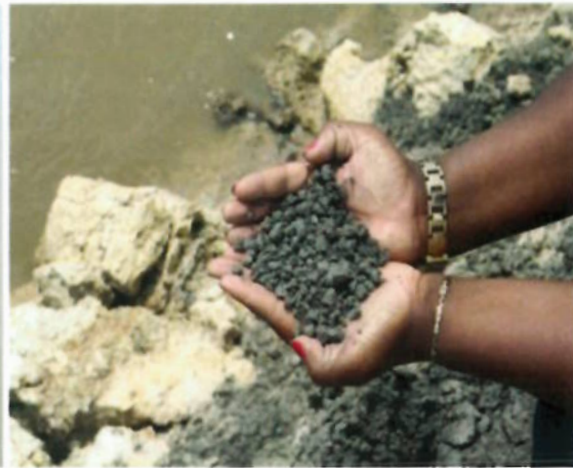
Plate 4.10: Weakly cemented soils

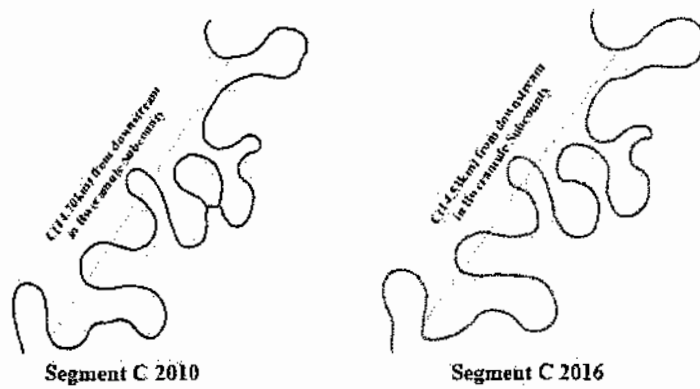
Appendix 21: Formation of ox-bow along River Scmliki meander

River Semliki exhibits active meandering. According to the Atlas of Our Changing Environment by NEMA (2009), despite the fact that River Semliki is in its old stage, and like any aging River, it has characteristic meanders and forms oxbow lakes in some places. In spite of its old stage, it still has enormous erosive power which is realized when it emerges from the forested Semliki National Park onto the Semliki flats in Rwebisengo and Bweramule sub-counties in Ntoroko District. The Atlas further notes that the increased River bank erosion due to overgrazing and degradation of the water catchments has resulted in siltation changing the River course significantly over the years as it enters Lake Albert. Results from this research reveal that River Semliki has exhibited changes since 1986 i.e the river meanders migrate downstream over time, which has led to the formation of Oxbow lakes along the river where meanders cut off from the main stream (Appendix 21) thus reduction in the length of the river.

(Appendix 21). The formation of new meander bends was observed in two places during this period which led to the shortening of the channel course. It was also observed that the River course in 2016 (101.6km) became shorter by 2.20 km than that in 1986 (Appendix 28).
